Special Investigation Report: Evacuation of  
United Airlines DC-8-61, Sky Harbor  
International Airport, Phoenix, Arizona  
December 29, 1980

(U.S.) National Transportation Safety Board  
Washington, DC

9 Sep 81

**NTSB-SIR-81-4**

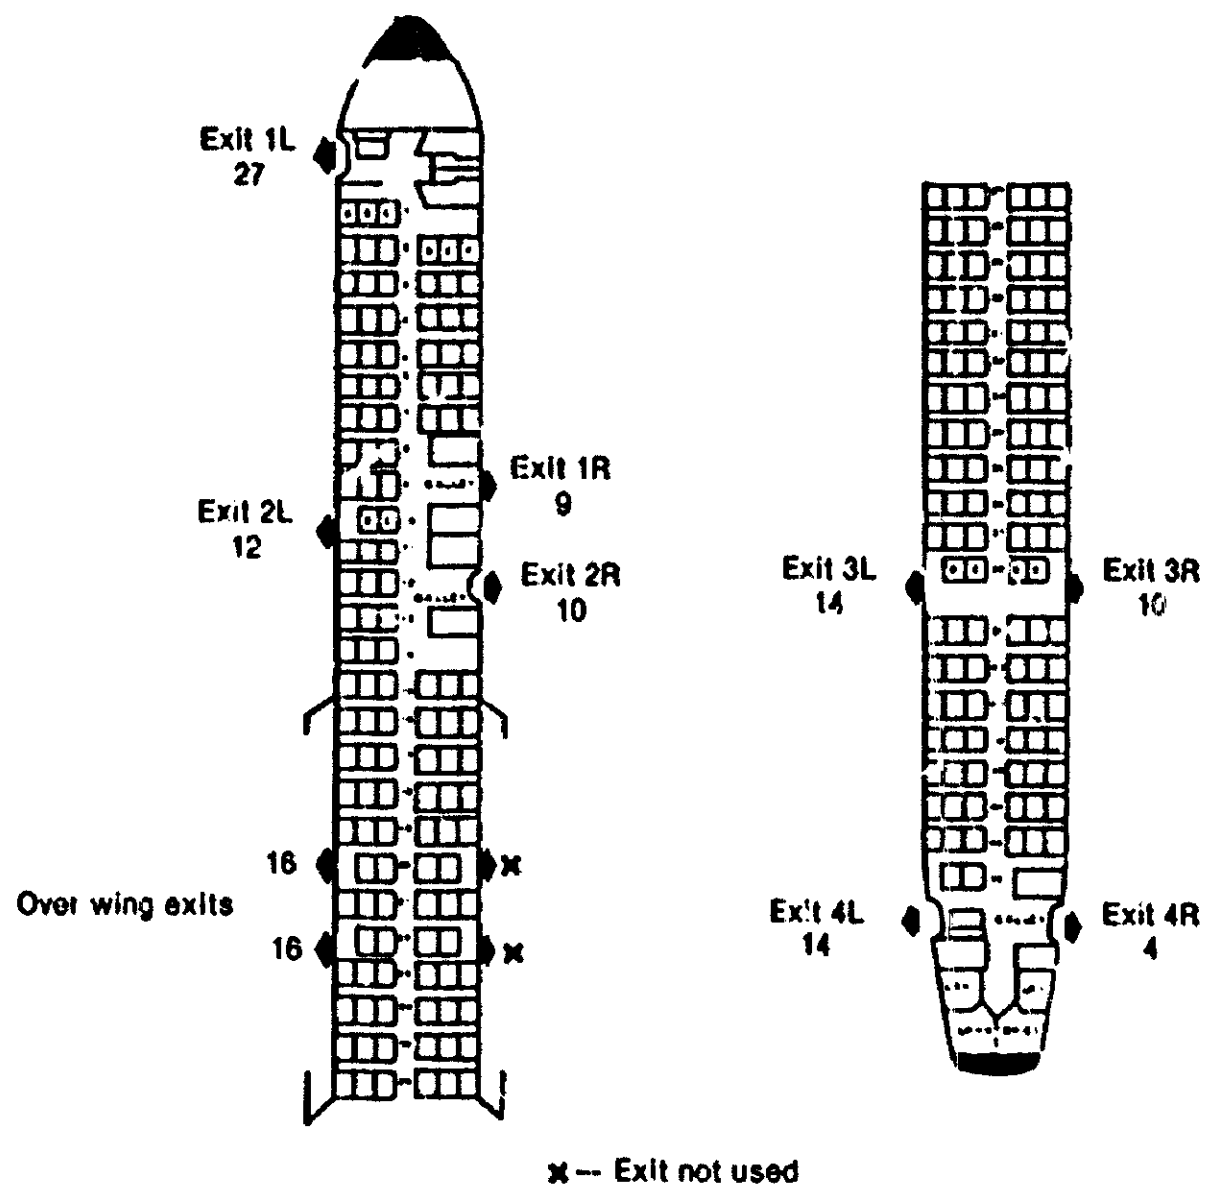
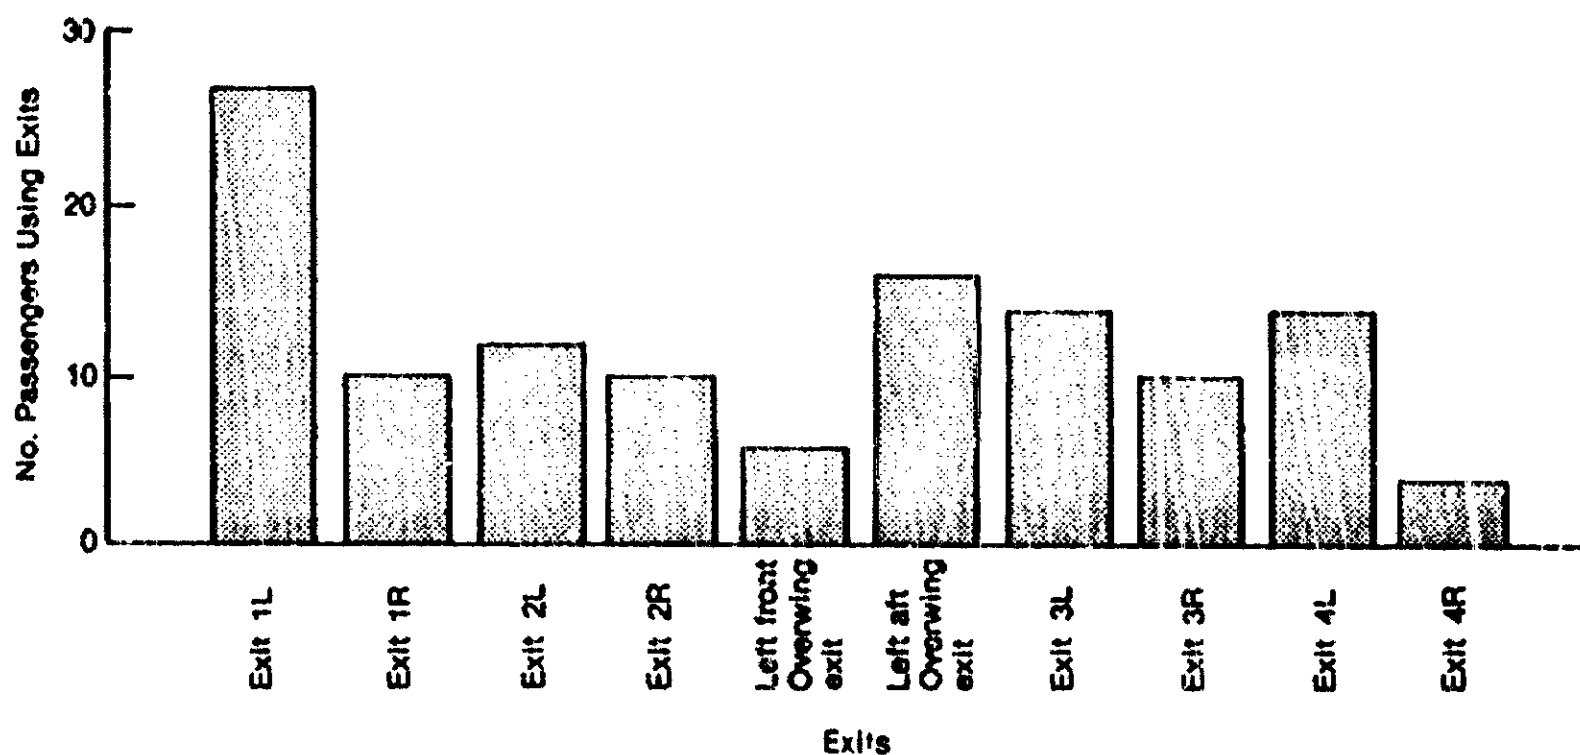
**Figure 3.**  
Depletion of exit utilization of the United Airlines DC-8 which was reported by 122 of the 148 passengers who responded to the passenger questionnaire.

Once the evacuation was fully underway, flight attendants had opened 10 of the 12 exits; the 2 right-side overwing exits remained closed. The flight attendant assigned to the right-side overwing exits originally opened one of these exits, but upon seeing flames and smoke through the open exit, she decided that the exit was unusable and closed it. Flight attendants had some difficulty opening exits 3L and 4R. A passenger had to assist a flight attendant in opening exit 3L, while the flight attendant assigned to open exit 4R had to obtain assistance from another flight attendant. (See figure 3.)

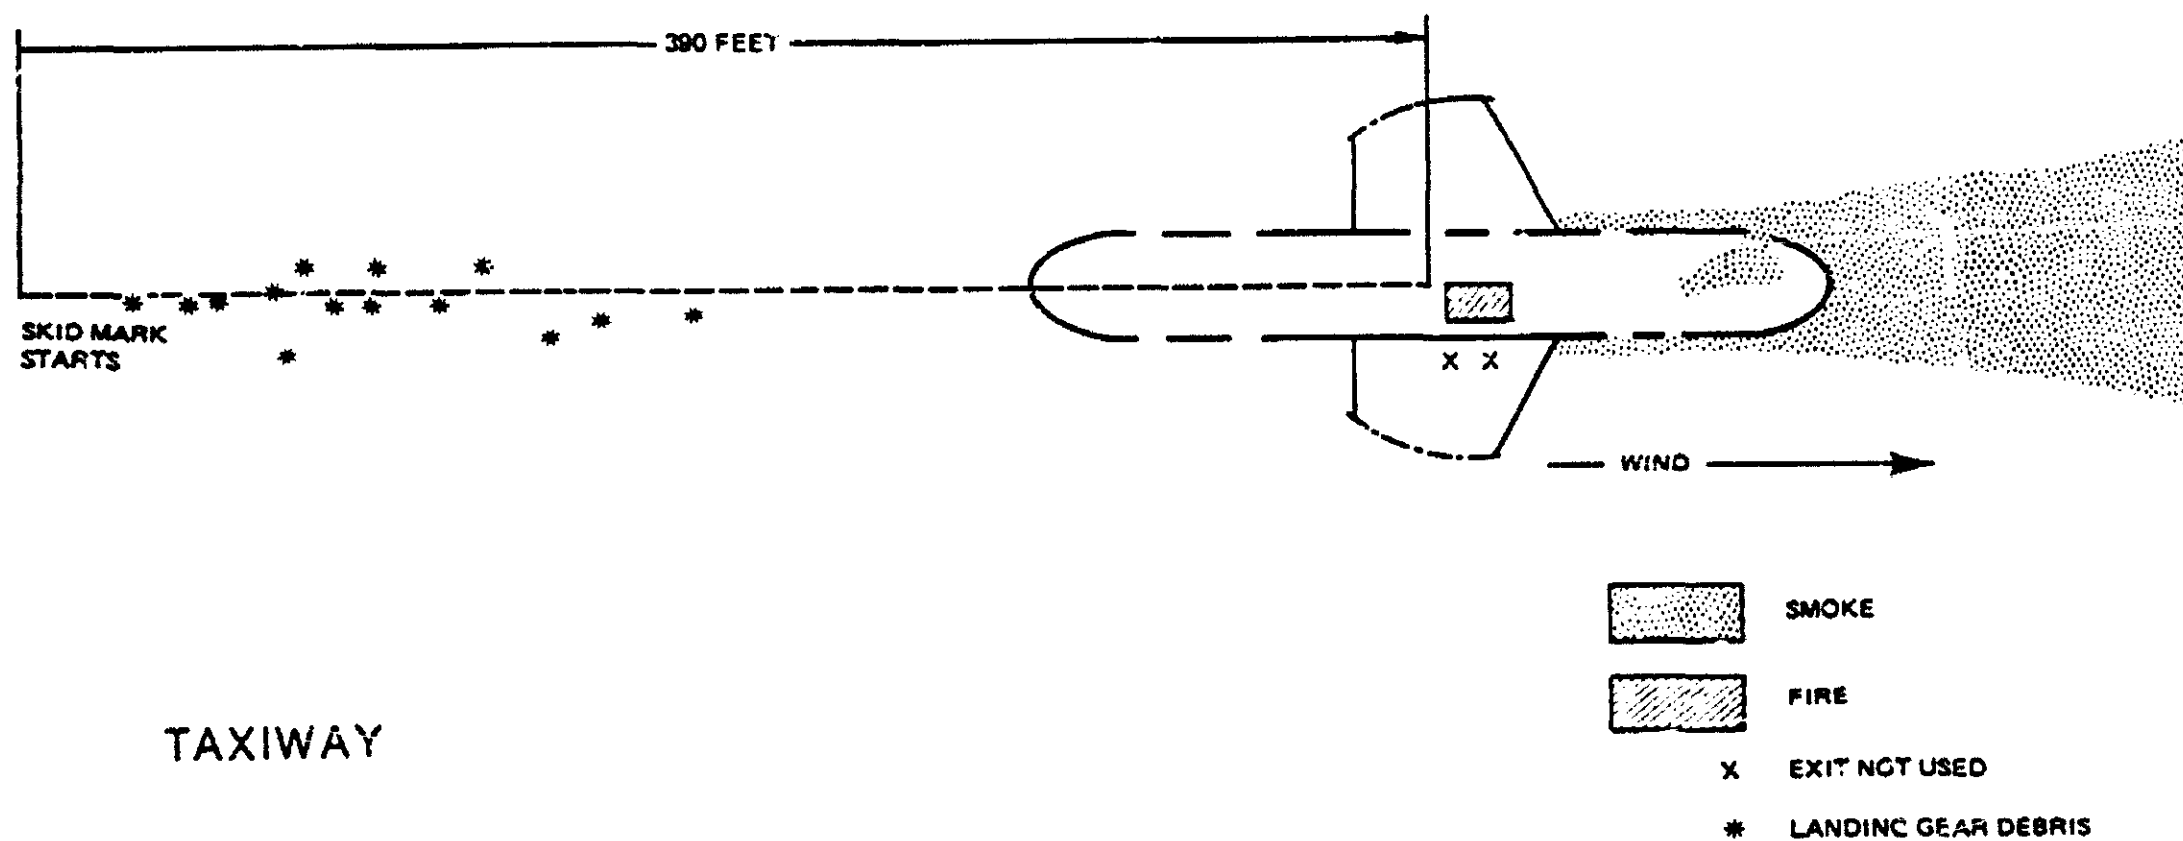
Figure 4.—Path and final position of United Airlines DC-8.
